# EFICIENCIA OPERATIVA IMPULSADA POR IA

Andrea Bilbao, Head of Customer Success,  
Jornada Operativa de Parques Eólicos, 02/10/2025

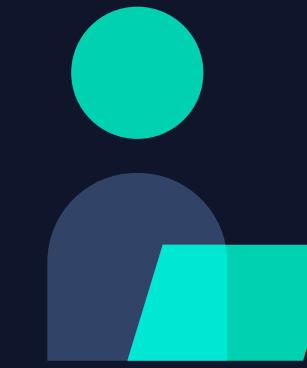
BÚSQUEDA EN  
DOCUMENTOS

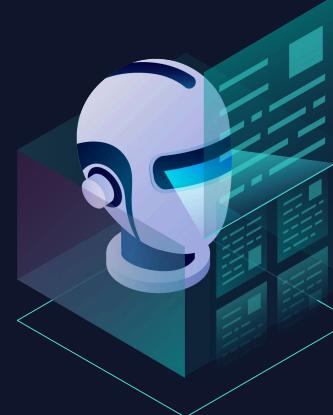
GESTIONAR FALLAS Y RESOLVER  
RETRASOS EN LA SOLUCIÓN DE  
PROBLEMAS

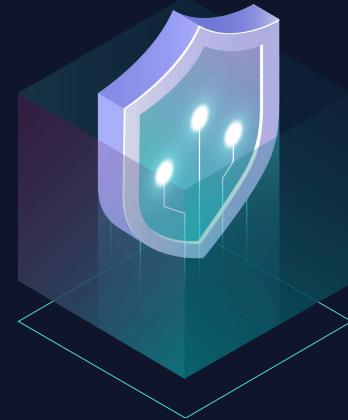
| Priority | Source | Component | Date of Initial Identification | Issue Description | Timeline | Update |
|---|---|---|---|--|--|--|
| Resolved | W03T03 | Main gearbox | 2016-04-25 | Contamination detected in oil; high zinc levels suggest mixing with zinc-containing oil or residues. Oil cleanliness below recommended standard. | 2016-04-25: Contamination detected, filter replacement advised.<br>2019-07-16: Increased copper levels, but oil within standards.<br>2022-10-23: All values within tolerance, no deviations. | Latest lab report confirms contamination resolved. Priority updated to Resolved. |
