Wind Turbine Towers & Foundations health monitoring

Operation, repower and life extension plans

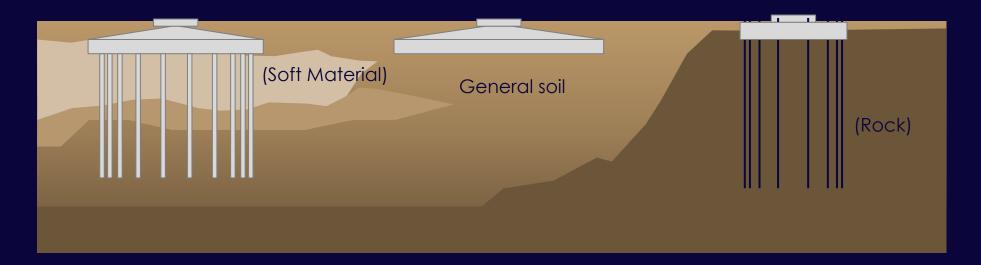
Onshore foundations – types

Piled / Deep Foundations	Gravity / Spread / Shallow Foundations	Rock Anchored Foundations
Ground Conditions	Compressible layers below the foundation	General conditions	Shallow bedrock

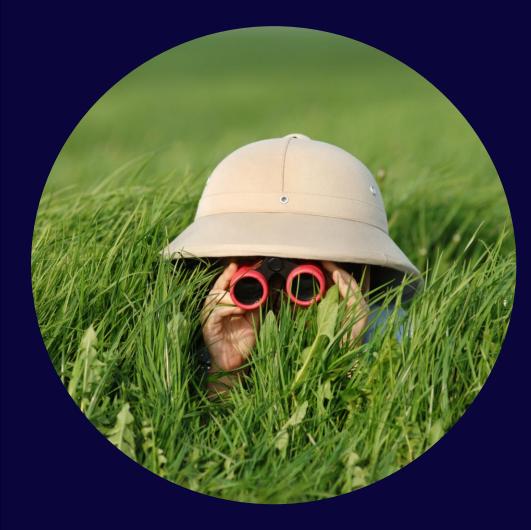
Using an Analytical Lifetime Evaluation

Strengths

- Analytical results, though not specifically predictive, are informative
- Illustrate the level of risk in comparison to other projects

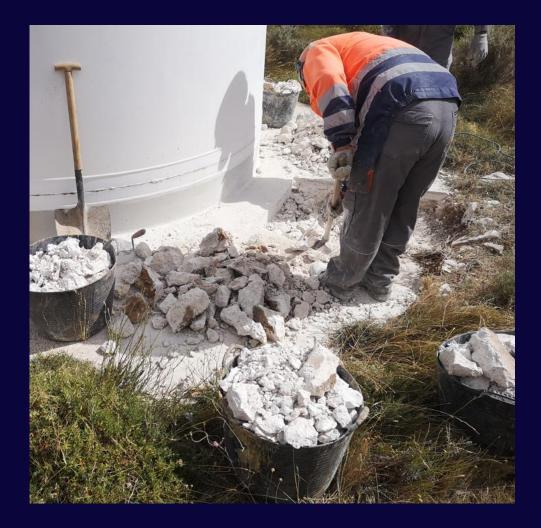
Destructive tests – "Live" opinion Visual inspections of the concrete

90° around foundation – predominant wind direction mainly

Rebar fractured? Damaged? Take some pictures

Repair – Never reach the same quality after repair

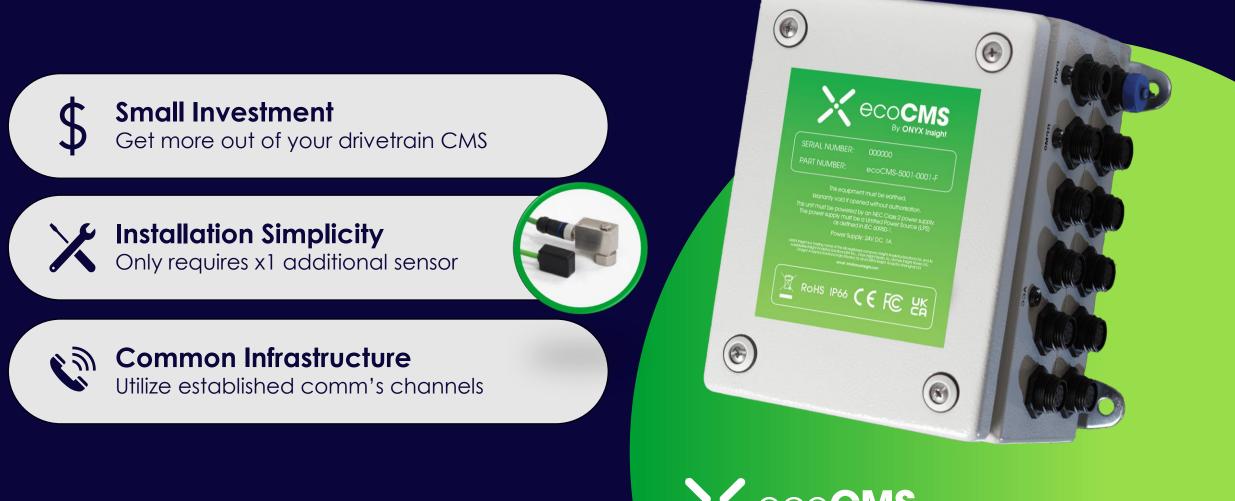
Overcoming Barriers to Unlocking a Bigger Monitoring Population

- Take advantage of drive train ecoCMS
- 1 additional MEM sensor installed up tower
 - Easy installation \rightarrow Epoxy
 - No WTG modification required
- Continuous monitoring
- Frequency vs time
 - Frequency changes with mass or stiffness
 - Stiffness changes imply degradation or damage

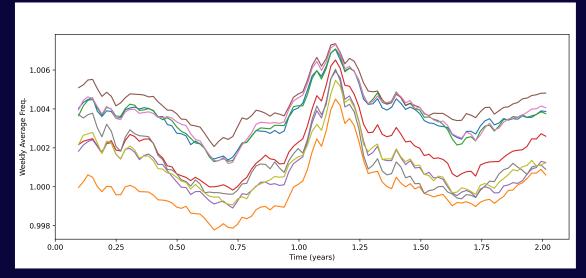
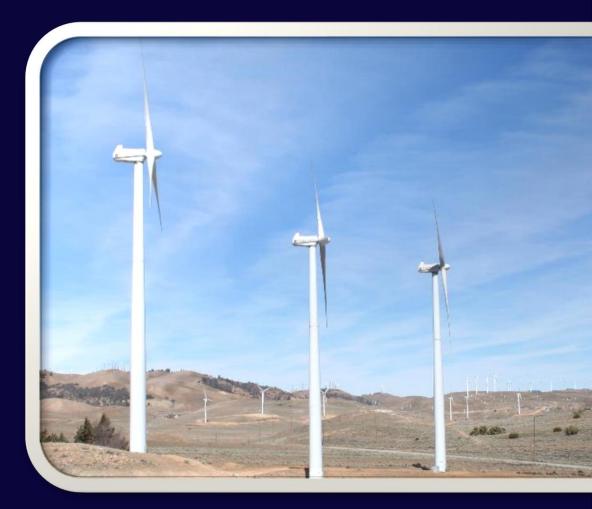
Tower frequency monitoring – foundation health

- Continuous measurements register over 2 year
- Frequency vs time
- Onshore seasonality tends to be periodic on an annual basis and dominated by temperature fluctuation

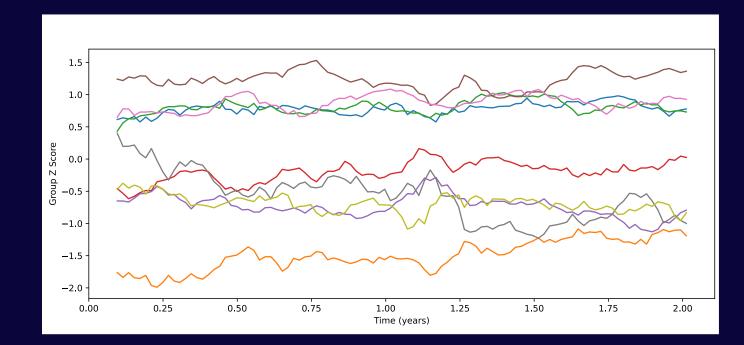
Group and Self Comparison

- Evaluating statistics of the group clarifies the picture and minimizes seasonal noise
- Some turbines are simply "healthier" than others
 - Stiffer soils
 - Higher strength concrete
 - Variation in foundation design
 - Variation in towers
 - etc.

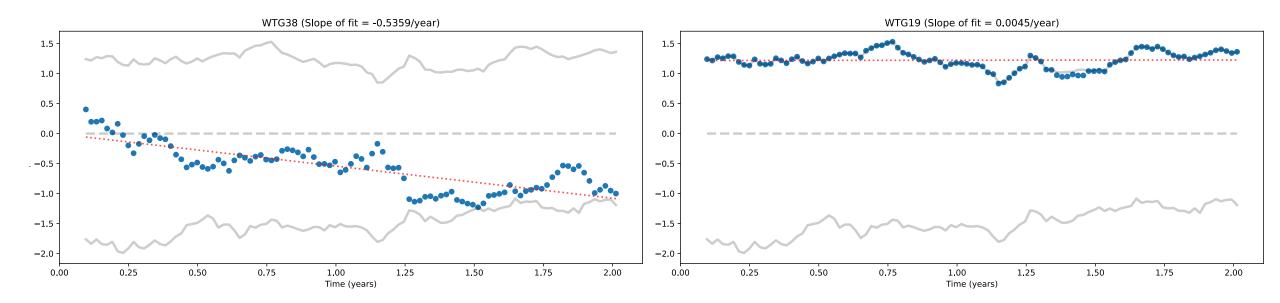
Quantify Health Metrics and Their Rate of Change

- Regularly measure a quantitative metric that represents health
- Observer the change (or lack of change) over time

- Estimate Safe Operational Limits and Schedule Action
- Base on observation and not just a projection
- Plan possible remediation activity into budgeting in 2 years
- WT38 requires investigation Continue operation and revenue generation in the meantime
